# KOZZA RAILING SYSTEMS

## BALUSTRADE TESTING IN ACCORDANCE WITH BS 6180:2011

**DOCUMENT REFERENCE: DR-5577**  
**PROJECT FILE REFERENCE: P10159**

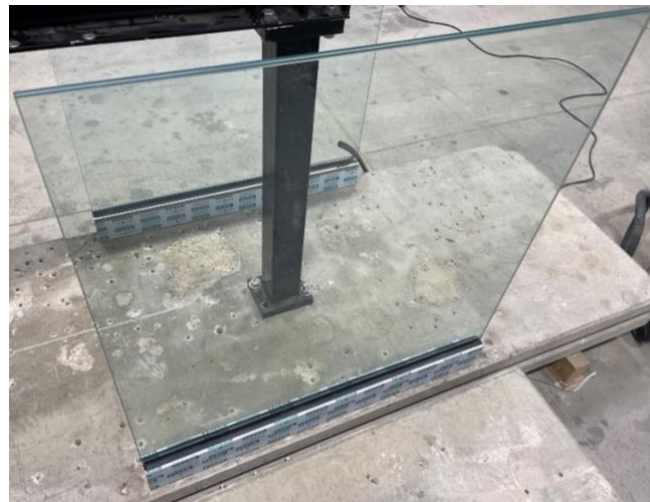
Test	Target Load	Load Achieved	Maximum Displacement (mm)	Classification
Line Load	0.74kN/m	0.74kN/m	18.91	Pass
Infill	1.00kN/m <sup>2</sup>	1.00kN/m <sup>2</sup>	3.72	Pass
Point	0.50kN	0.50kN	5.06	Pass

Testing was completed successfully with the balustrade system achieving loading values for the 0.74kN specification, with a maximum recorded displacement of 18.91mm, resulting in a pass. All testing was carried out in accordance with BS 6180:2011.

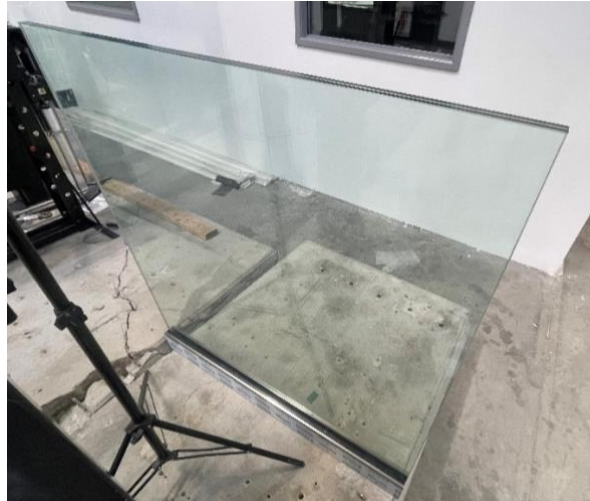
Test	Target Load	Load Achieved	Maximum Displacement (mm)	Classification
Line Load	0.74kN/m	0.74kN/m	23.47	Pass
Infill	1.00kN/m <sup>2</sup>	1.00kN/m <sup>2</sup>	8.03	Pass
Point	0.50kN	0.50kN	4.24	Pass

Testing was completed successfully with the balustrade system achieving loading values for the 0.74kN specification, with a maximum recorded displacement of 23.47mm, resulting in a pass. All testing was carried out in accordance with BS 6180:2011.
